**Engineers Australia  
Engineering Heritage Victoria**

## **Nomination**

# **ELDORADO GOLD DREDGE**

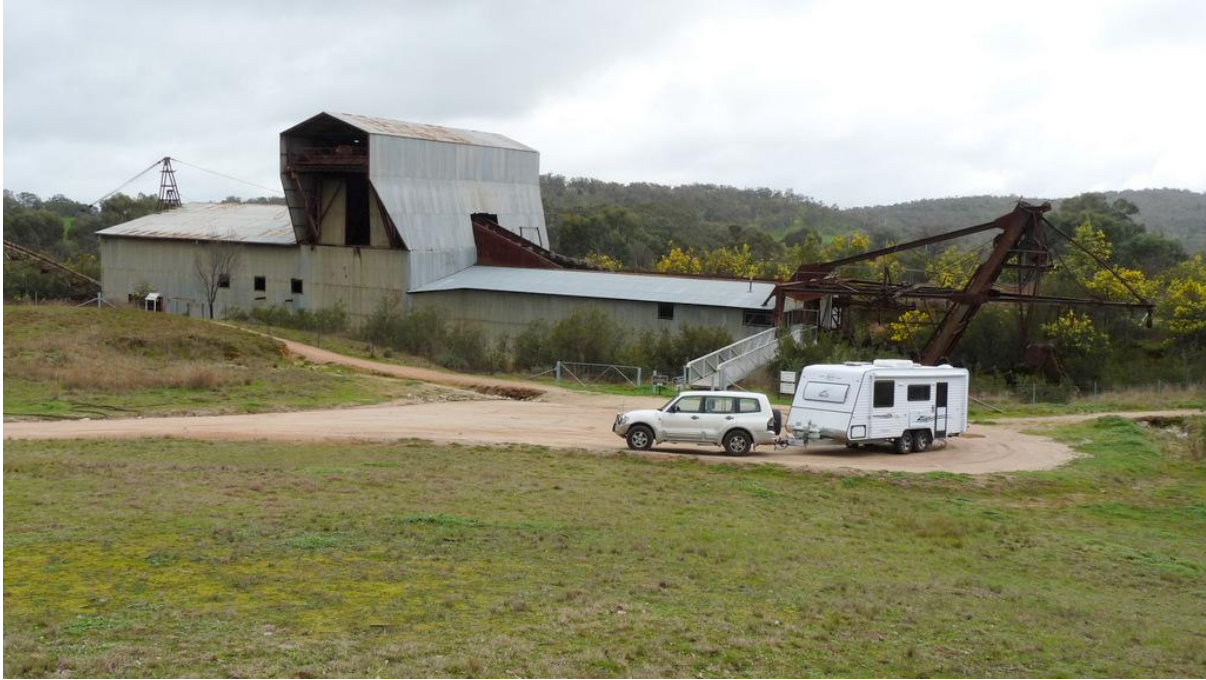
Figure 1: Eldorado Dredge viewed from SE, partly obscured by trees and by the earthen banks of its pond. Bow end with bucket ladder and fore-gantry at right, superstructure at centre, stern with discharge chutes at left. (Photo by Phelan, from the Web.)

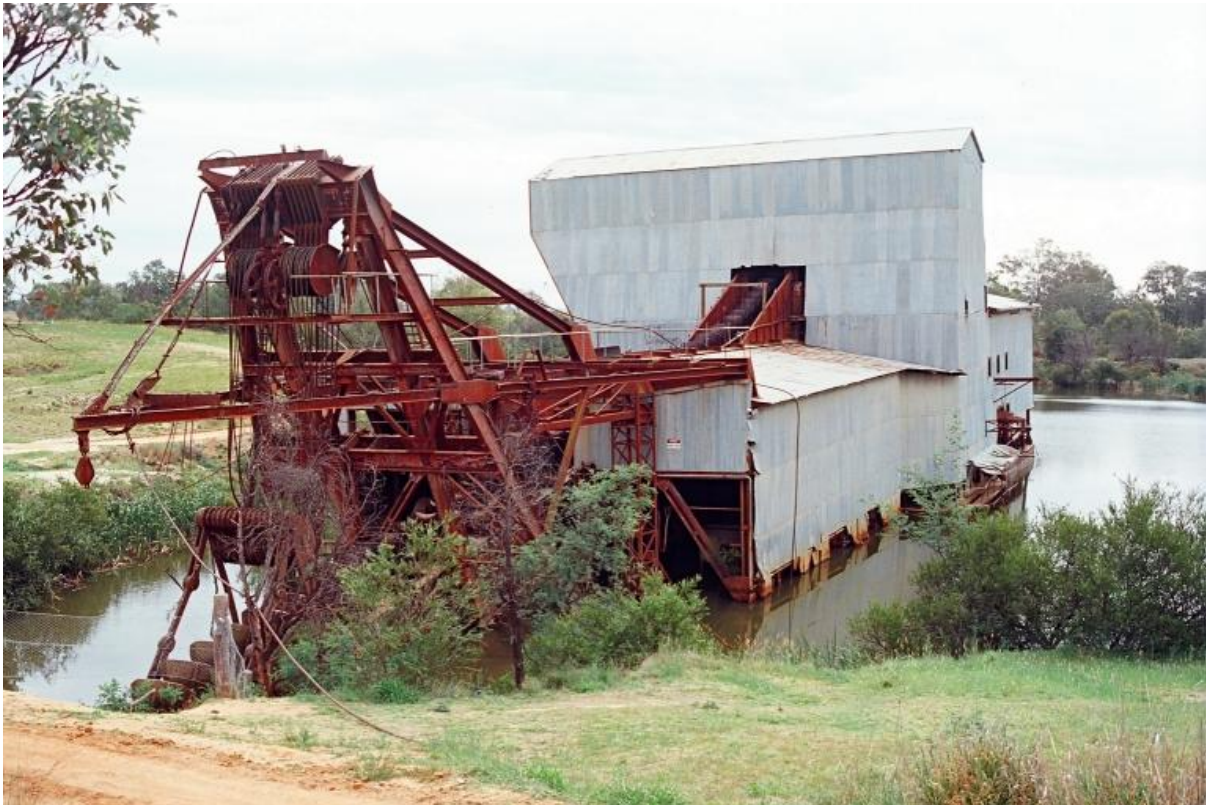
Figure 2: General view of the dredge, seen from East, with bow end in foreground. Note the upper end of the inclined bucket ladder emerging from an opening in the tall central section of the superstructure, and the lower end with buckets at bottom left corner of the photo. Also in foreground is the fore-gantry frame with pulleys and steel cables to raise or lower this end of the bucket ladder. (Photo C. Doring 1994)

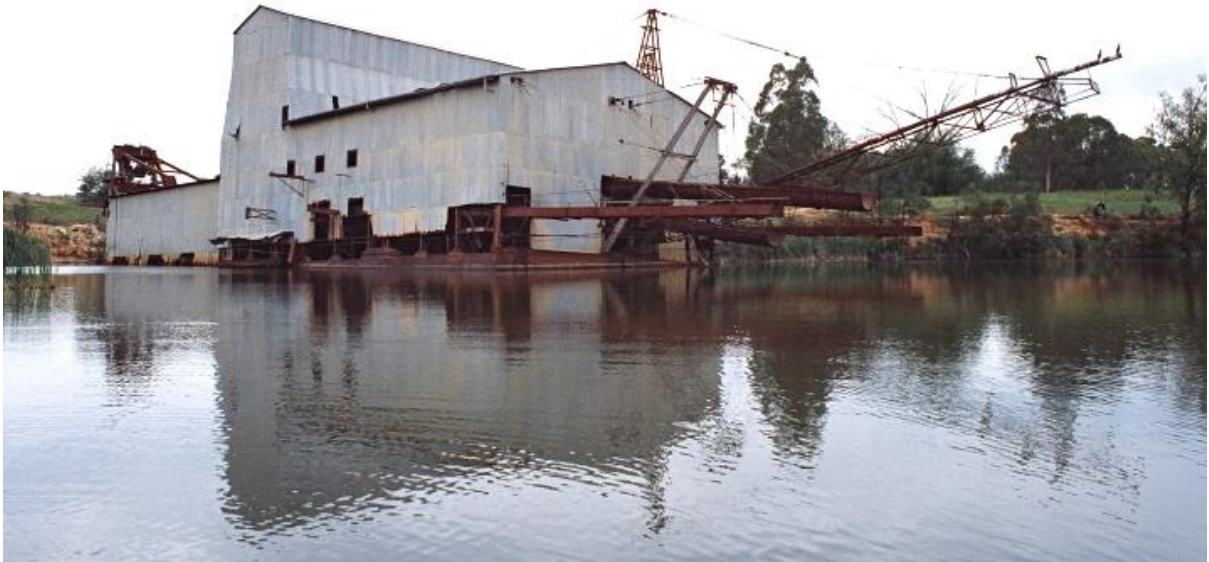
Figure 3: General view of the dredge from NW, showing the bow end at far left and the stern end at centre, with gravel-disposal chutes protruding from the stern at right. . (Photo by C. Doring 1994.)

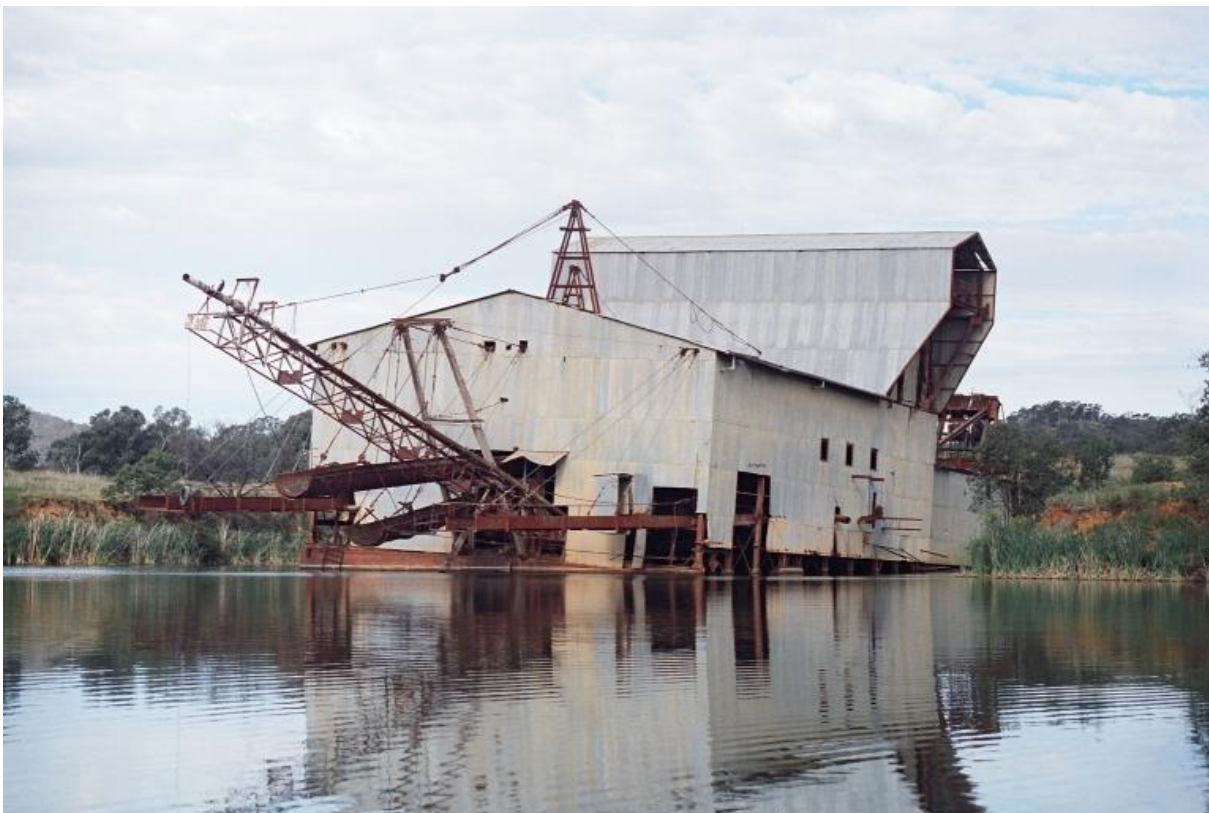
Figure 4: Stern view of the dredge, seen from SW. Note the tilt towards the front-right corner. Note also how the upper part of the tall central superstructure protrudes to allow the manual overhead crane to move heavy equipment on or off a barge alongside. (Photo by C. Doring 1994.)

Milner tried to refloat the dredge, but unfortunately Milner's pumps, with a combined capacity of about 3000 gallons per minute (about 13,000 litres per minute) could empty some hull compartments but could not keep up with the inflow of water through external holes in other compartments, and the refloating attempts failed. Milner's several reports from 1989-1990 show that by then the dredge was firmly settled on the gravel bed, and had sunk furthest at the bow end, particularly at the starboard (right) corner of the bow end, leaving the whole dredge tilting a bit towards that corner - as it is today.

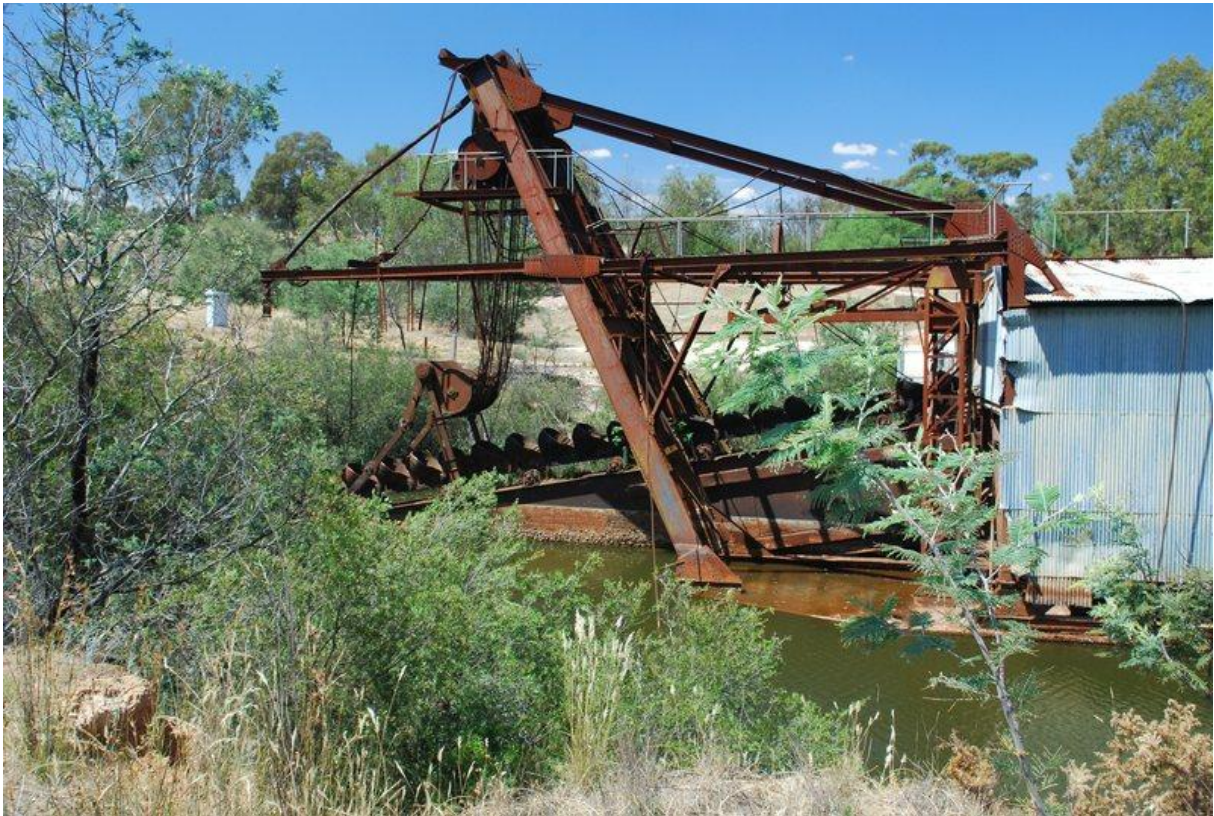
Figure 7: Bow end of the dredge viewed from north, showing the inclined fore-gantry, sitting on the partly submerged front forks of the pontoon. Also shows part of bucket ladder, and the supporting cables and pulleys, (now hanging slack). (Photo from Heritage Victoria website.)

The rear end of the bucket ladder was secured by a pivot shaft set high in a tall central section of the superstructure. The forward end of the bucket ladder passed between the legs of a fore-gantry frame straddling across the slot in the forward pontoon, and was supported by two steel cables and two sets of pulleys hanging from the gantry. A winch on the forward starboard deck could wind in or let out the cables, raising or lowering that end of the bucket ladder and so controlling the depth from which the buckets dug up gravel.

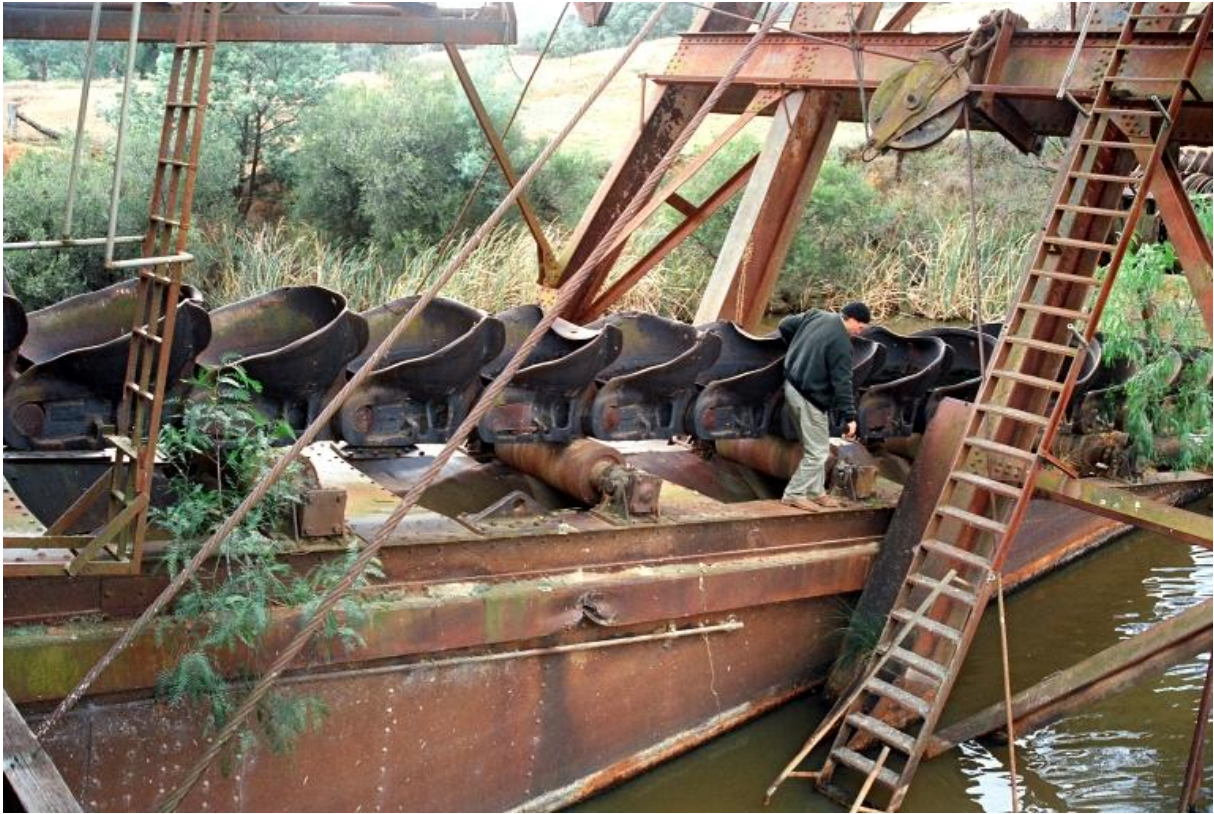
Figure 8: Forward end of the bucket ladder, near the submerged tip. Viewed from SW, with a Park Ranger for scale. The bucket band sits on rollers on the top face of the bucket ladder, and here passes between legs of the fore-gantry. The bottom tumbler and lower buckets are submerged. (Photo by C. Doring 1994.)

The buckets at the protruding tip of the ladder scooped up about one-third of a cubic metre of gravel each, then travelled upwards and rearwards along rollers on top of the sloping “ladder” until they passed around the slowly rotating top tumbler near the upper end of the ladder. The top tumbler was in fact a 6-sided drive sprocket designed to grip the underside of each bucket and pull the upper half of the bucket-band with enough power to force the far-end buckets through the bed of gravel and raise the heavy full buckets up the ladder.

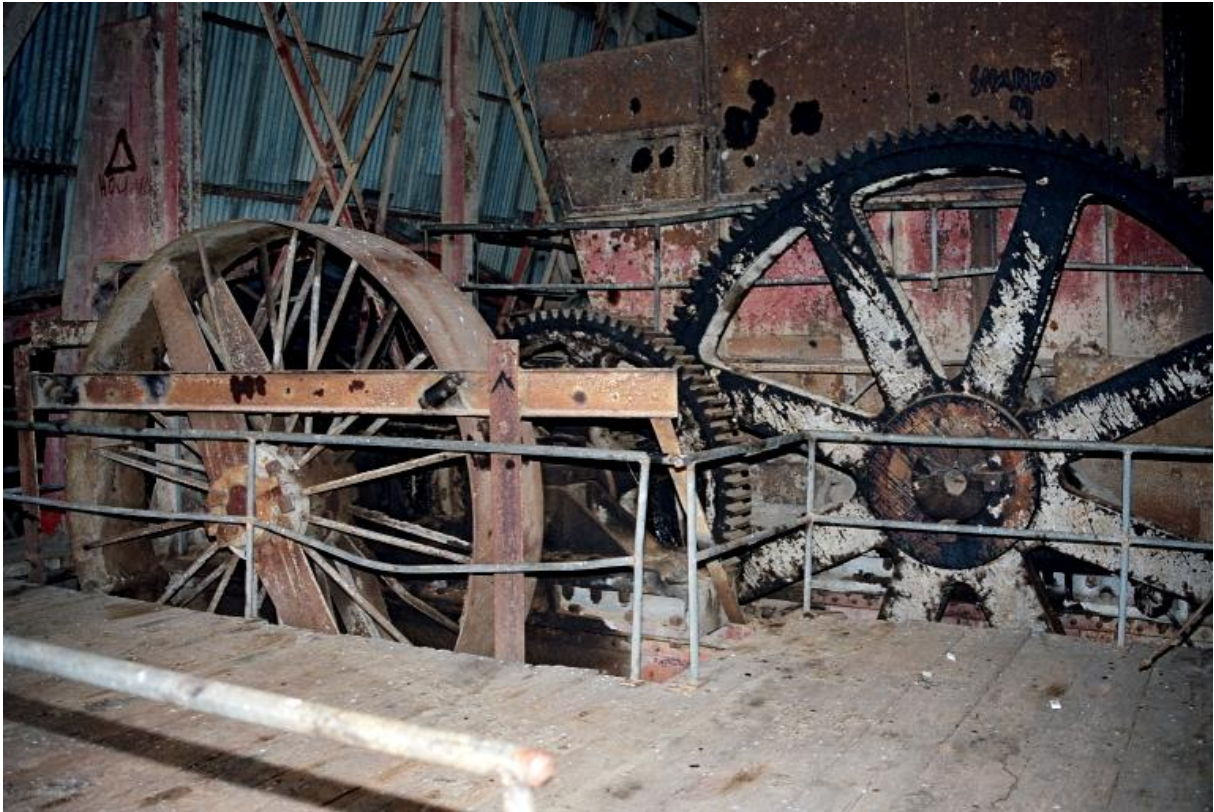
Figure 9: Large gears (right and centre) driving the top tumbler (hidden) that drove the bucket band. These are next to the top of the bucket ladder (also hidden), set high in the central superstructure. Power came from a large electric motor on the deck far below, via a flat belt onto the flat-face pulley at left (belt now missing). The waist-high guard railing gives scale. (Photo by C. Doring 1994)

The top tumbler (drive sprocket) for the bucket band was driven by a series of large gear wheels high in the tall central section of the superstructure, which in turn were driven by a large flat-face pulley connected by a flat endless belt to a large motor on the deck far below. This belt and most other flat leather or rubber drive belts, typical of power transmission during the dredge’s working life, are now missing. The bucket drive motor was originally 200 hp (horse power), but was early on replaced by a 320 hp motor. The more powerful motor was quickly blamed for several breakages in the bucket-band, but this soon settled down to just routine wear-and-tear of the buckets.

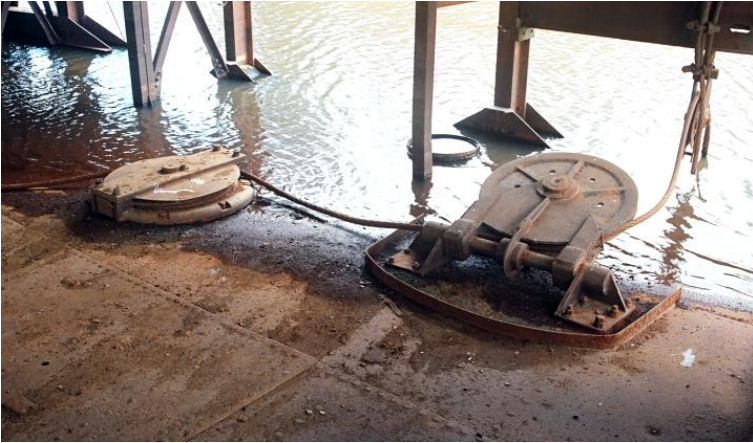
Figure 10: Mooring pulleys on the deck near the stern, starboard side. The left pulley is one of several guiding the exposed cable across the deck from the winch to here. Cable from the right-hand pulley goes to an anchor point on land, and the pulley swivels to accommodate variations in anchor height.

The dredge was moored and manoeuvred by a series of steel cables running from the dredge to anchor points (eg trees) on land nearby. A set of four linked winch drums at deck level, beneath the control room on the starboard pontoon, controlled four heavy steel mooring cables that originally ran across the deck to single-wheel pulleys at the four corners of the pontoon, then ran out sideways from the corner pulleys to four anchor points. Later, the two pulleys at the bow end were raised and crudely lashed onto the upper fore-gantry, presumably so those mooring cables could clear any high earth banks near the area being excavated.

A mooring cable from a fifth winch drum ran forward to a fifth anchor point on land, to pull the dredge towards the area being excavated, and then to anchor the dredge so that the buckets would bite into the gravel and the reaction force would not drive the floating dredge backwards.

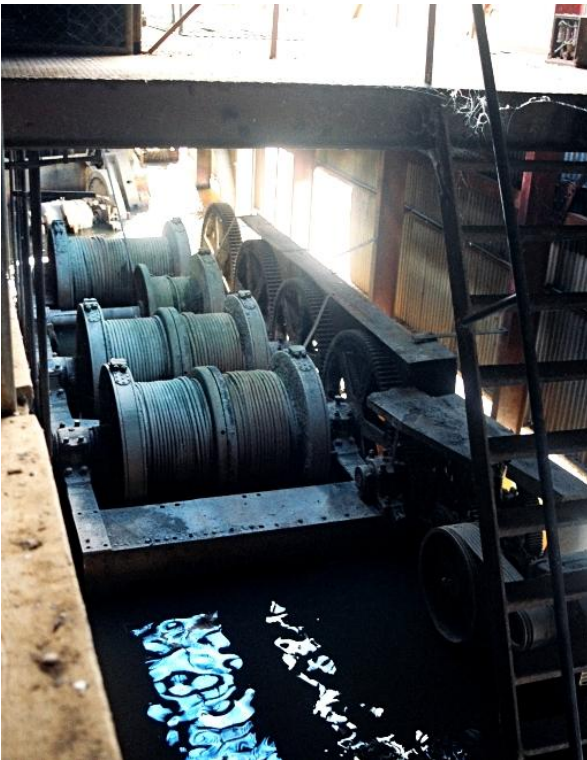
Figure 11: The linked winches for mooring and manoeuvring the dredge, on the semi-submerged deck beneath the control room, here viewed from stern end. (Photo by C. Doring, 1994)

The mooring and manoeuvring winch drums were all driven by the same electric motor and same drive shafts, via clutches, which allowed the Winchman to choose which winch drums to actuate and which to leave locked. When manoeuvring sideways the four drums (two shafts) nearest the camera normally ran together at the same speed and in the same direction. However, the starboard and port cables were wound onto the drums in opposite directions so that (say) the two starboard cables would wind out

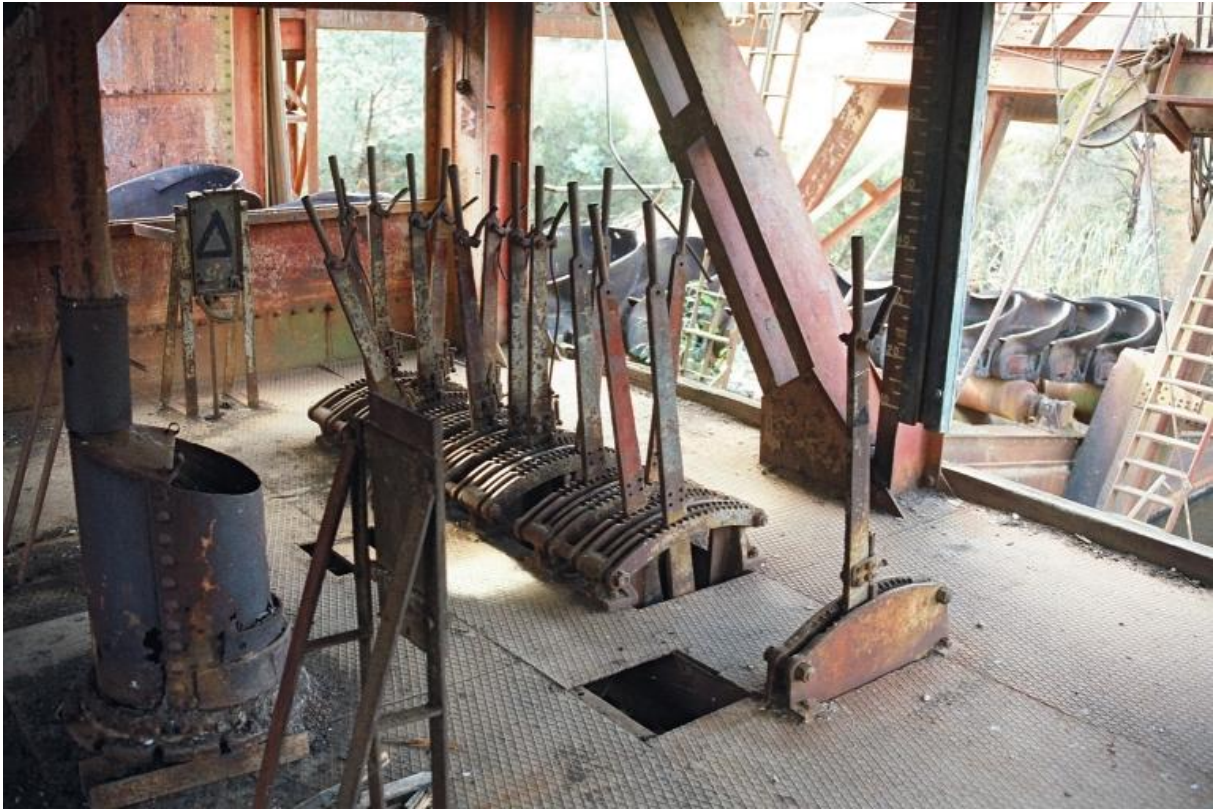
Figure 12: Levers in the control room, mechanically controlling clutches or brakes on the winch drums below. The open front wall normally had windows and cgi cladding, stolen here but since replaced. At left is a small stove for warmth – a rare concession to operator comfort. (Photo by C. Doring, 1994)

As noted above, the superstructure in the forward half of the dredge was divided into two halves by the central axial slot (bucket well) that accommodated the bucket ladder. The control room used by the Winchman to “drive” the dredge was located at the forward end of the starboard (right) half superstructure, at an upper level above the winches. The control room had windows giving the dredge controller (the Winchman) a good view of the forward

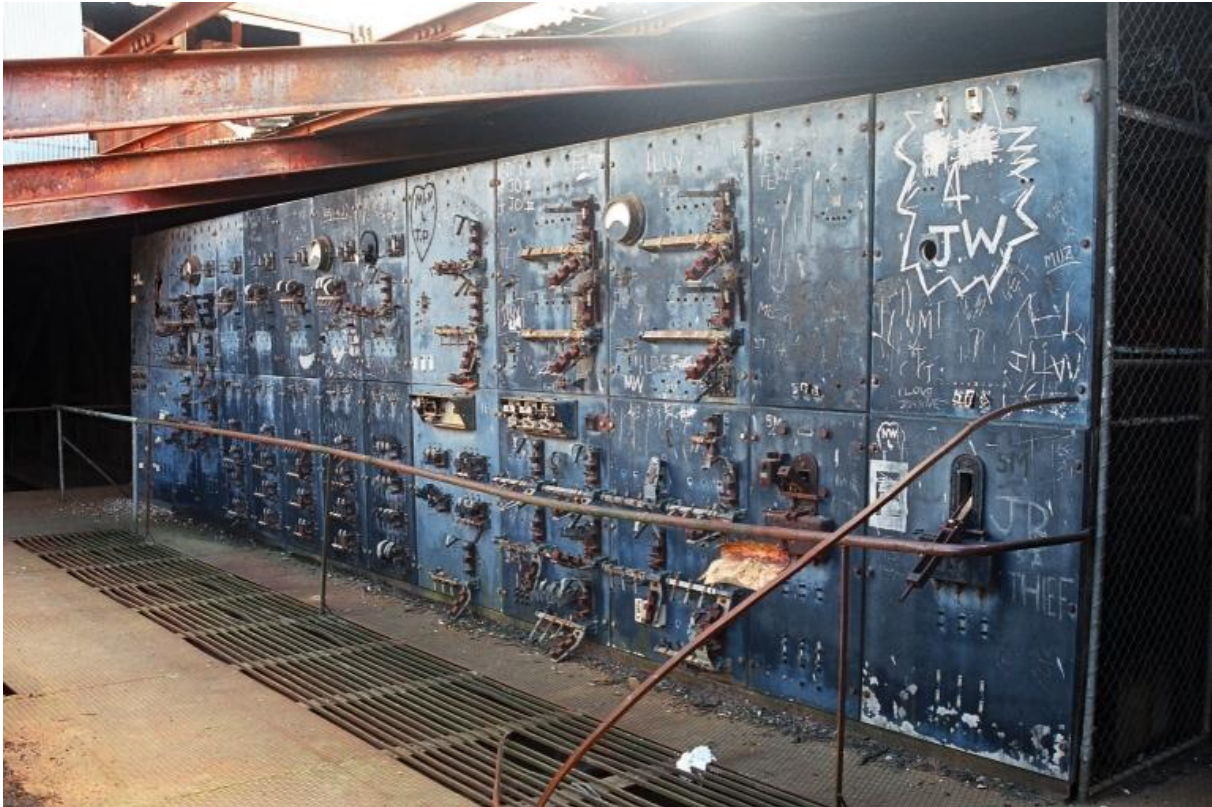
Figure 15: Switchboard in the Control Room as seen in 1994 with electric meters and manual switches (some open blade type) that monitored and controlled the various motors. Since then all meters have been smashed and some copper components and wiring stolen. Note the sparse safety guardrail. The grid floor panels gave the Winchman a view to the winches below. The cgi roof cladding above the Control Room was stolen, but has since been replaced. (Photo by C. Doring)

The control room had a large vertical electrical switchboard with open blade switches controlling the various electric motors, and with meters monitoring the current or power being drawn by the various winch motors, pumps etc. The control room also had a row of steel levers about a metre long protruding from the floor, looking like the switch levers in a traditional railway signal box. These levers mechanically controlled brakes and clutches on the various winches on the deck below. The control room floor was partly made of sheets of steel chequer-plate and partly of a grid of spaced steel bars, the latter giving a view onto the winches below.

Vandals and thieves have also caused some damage, such as removal of most flat drive-belts, some cgi roofing, many of the circular deck-top manhole covers, most electrical wiring and most light fittings. Vandals have also smashed or removed all electrical meters on the Winchman's control-room switchboard.

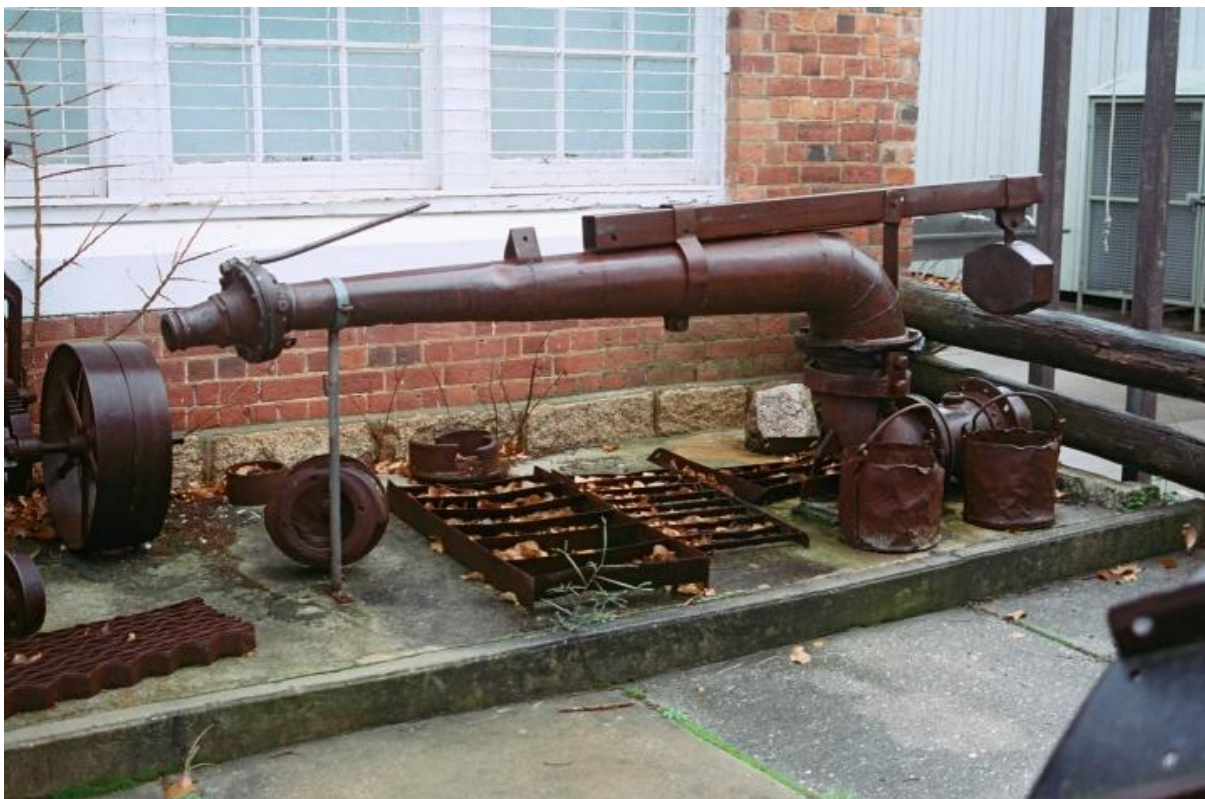
Figure 16: Sluicing nozzle on display at Eldorado Museum. (Photo by C. Doring, 1994.)

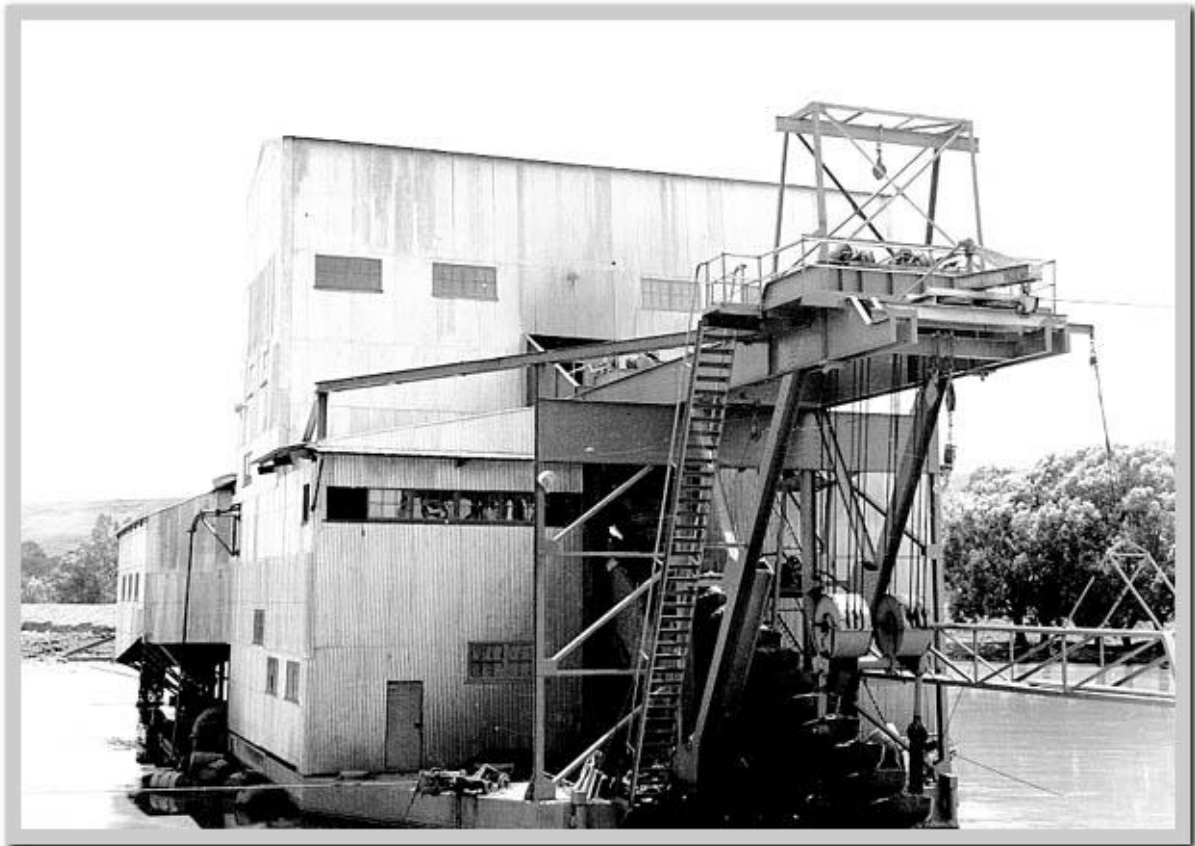
Figure 18: Newstead Dredge. (Photo from Victorian Dept of Energy and Resources website.)

One well-known 1930s all-steel dredge, variously called the Newstead Dredge or the Victoria Dredge, was owned by the Victoria Gold Dredging Company and operated from 1938 to 1948 on the Loddon River near Newstead in the Central Goldfields area of Victoria, about midway between Bendigo and Ballarat. That dredge was designed by George Watson of Alluvial Mining Equipment, Sydney, and was made by Thompsons in Victoria.

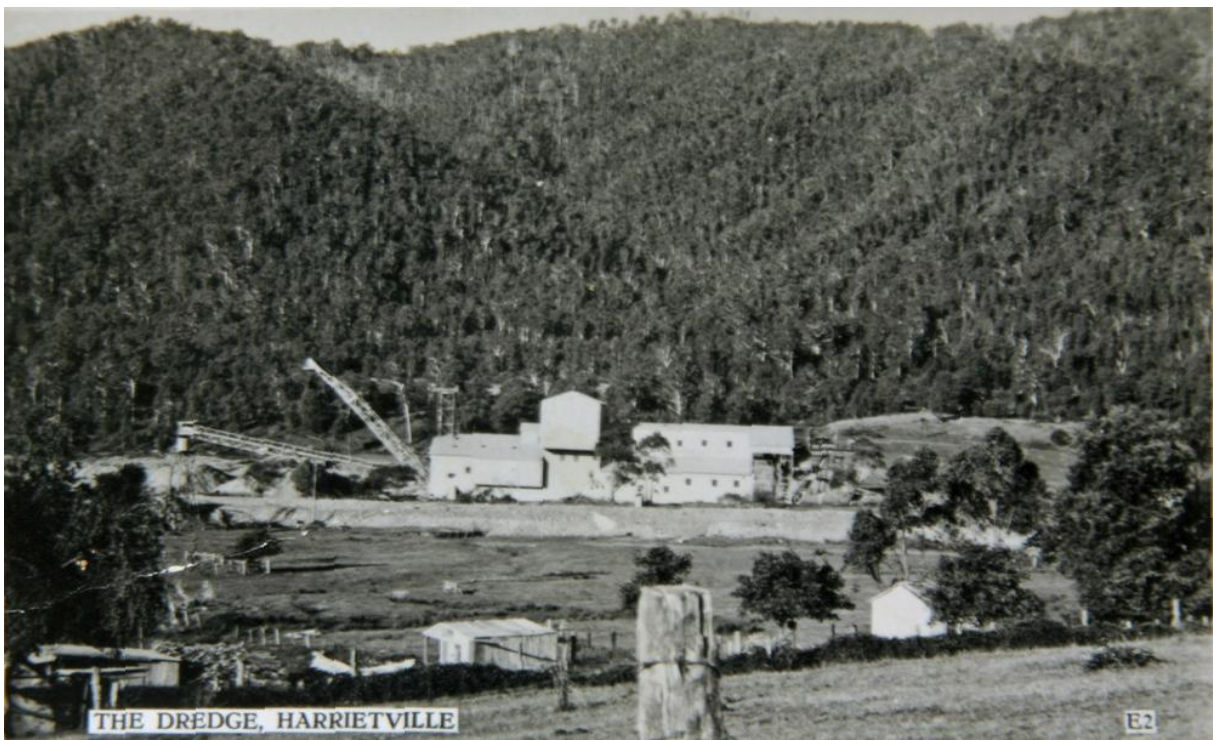
Figure 19: Old postcard photograph of the Tronoh Dredge working near Harrietville, Victoria. (Copied from Web)

The largest bucket-style gold dredge in Victoria - and probably in Australia - was the all-steel Tronoh Dredge which worked on the upper reaches of the Ovens River, near Harrietville. It was roughly 50% larger and 100% heavier than the Eldorado Dredge, and had electric motors with about double the power. It could dig down to 130 feet depth, about 50% deeper than the Eldorado Dredge, and could dig up gravel at about twice Eldorado's rate.

The Tronoh Dredge was owned by Harrietville (Tronoh) Limited, a subsidiary of the London Tronoh Company. The dredge was designed by F.W. Payne & Sons, London, but again was built by Thompsons of Castlemaine and Williamstown, Victoria. Construction of the Tronoh Dredge began in 1939, but WW2 intervened and the dredge was not completed and operational until 1942. It then had trouble getting enough men to work it, so did not reach full production until about 1946.

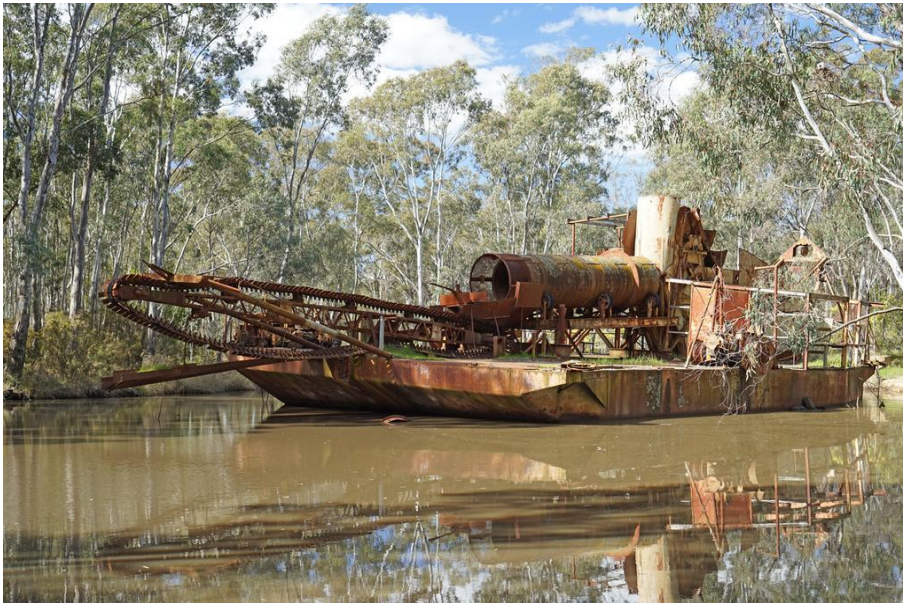
Figure 20:  
The Maldon Dredge,  
stern view.  
(Photo from Web)

Near Maldon in Victoria there is a remnant steel-hulled bucket dredge still with its short bucket ladder, bucket-band, and primary cylindrical gravel screen, but with little else of the gold recovery system or the superstructure still in situ. It is much smaller than the Eldorado Dredge. It is known generally as the Maldon Dredge, but is listed on the Victorian Heritage Register as the Porcupine Flat Dredge, Heritage Inventory Number H7724-0044, Hermes Number 8347.

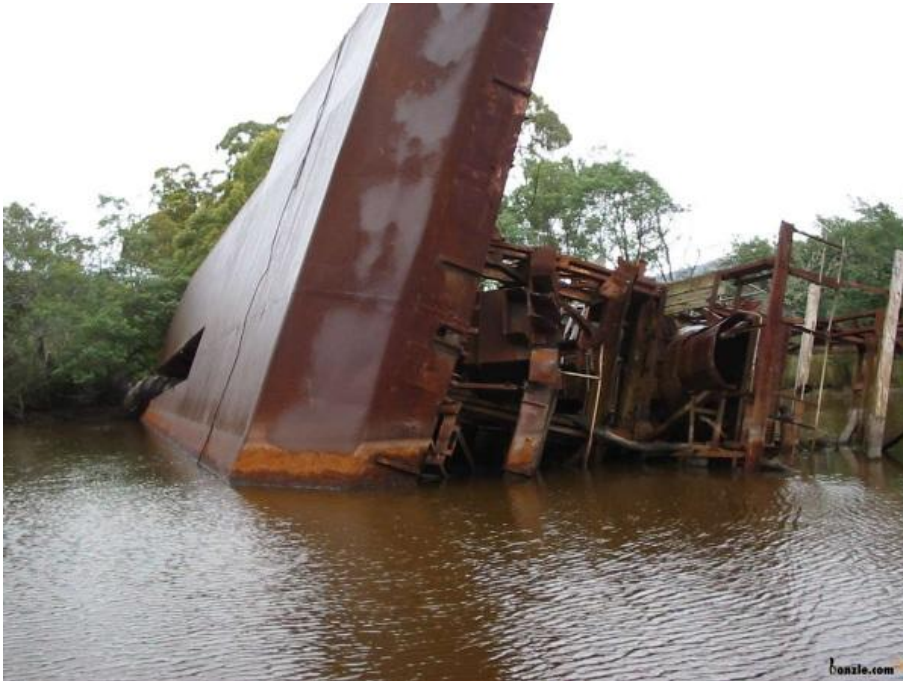
Figure 21:  
Dorset Dredge, NE  
Tasmania, stern view.

Near Ringarooma in north-east Tasmania, in the Dorset municipality, a wooden-hulled bucket dredge known as the Dorset Dredge was built c1906-07, to dredge for tin. Later, a steel-hulled Dorset Dredge replaced the wooden one. According to a 1968 report on tin production in Australia, the (steel) Dorset Dredge was then still operating as a mid-level tin producer, but was becoming uneconomical. Today the long-disused steel Dorset Dredge is still in situ in its own dredging pond, but has been tipped on its side - probably during a flood. Judging by on-line photographs, its superstructure cladding, buckets and onboard machinery have been mostly or totally removed.

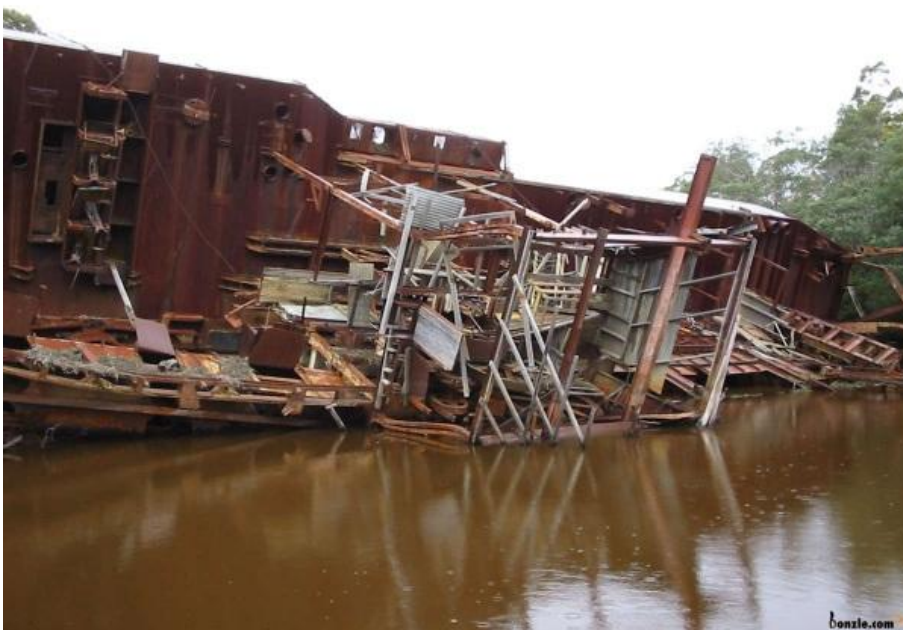
Figure 22:  
Dorset Dredge.  
Former top view, now  
side view, with bow end  
at right.

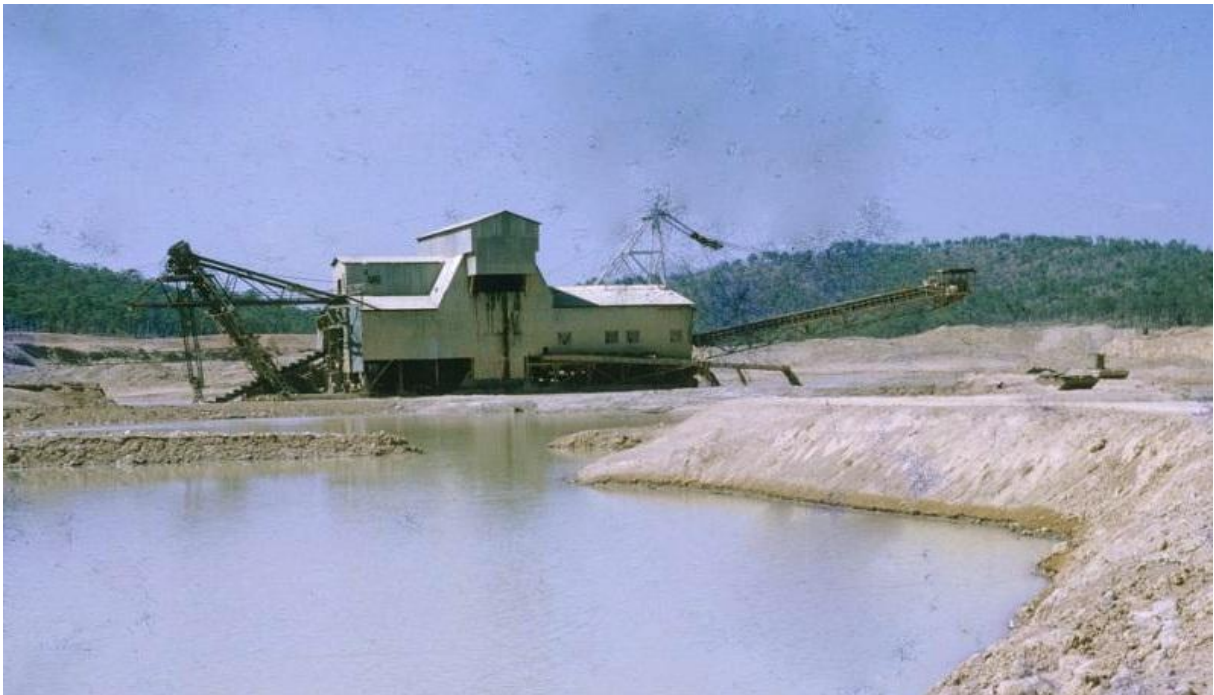
Figure 23: Nettle Creek Tin Dredge, Queensland, in working order. (Photo from web, trimmed)

The rebuilt dredge mined for alluvial tin along Battle Creek, near Mt Garnet, from 1957 to 1962. Its onboard equipment was then dismantled, transported a short distance and re-erected again on yet another steel pontoon (No.3) to dredge Nettle Creek for tin. It worked there from 1965 to 1992, when it was finally shut down.

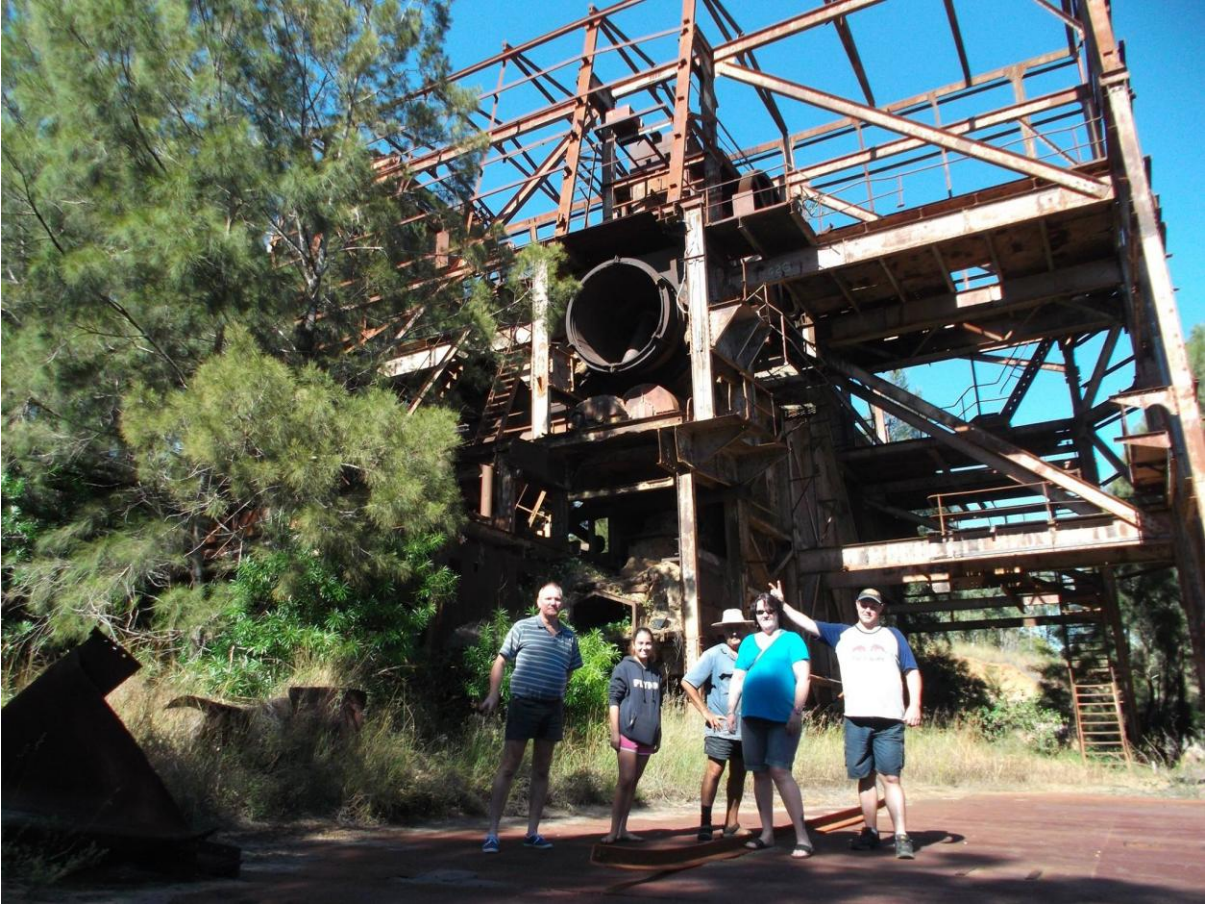
Figure 24: Nettle Creek Tin Dredge, present condition. (Photo from Innisfail Gem Club website.)

The now-disused Nettle Creek dredge still sits beached on the gravel bed in its last pond alongside Nettle Creek, about 14km east of Mt Garnet, but in a stripped-down condition.
