Bridgewater Bridge and Causeway

CROSSING THE DERWENT

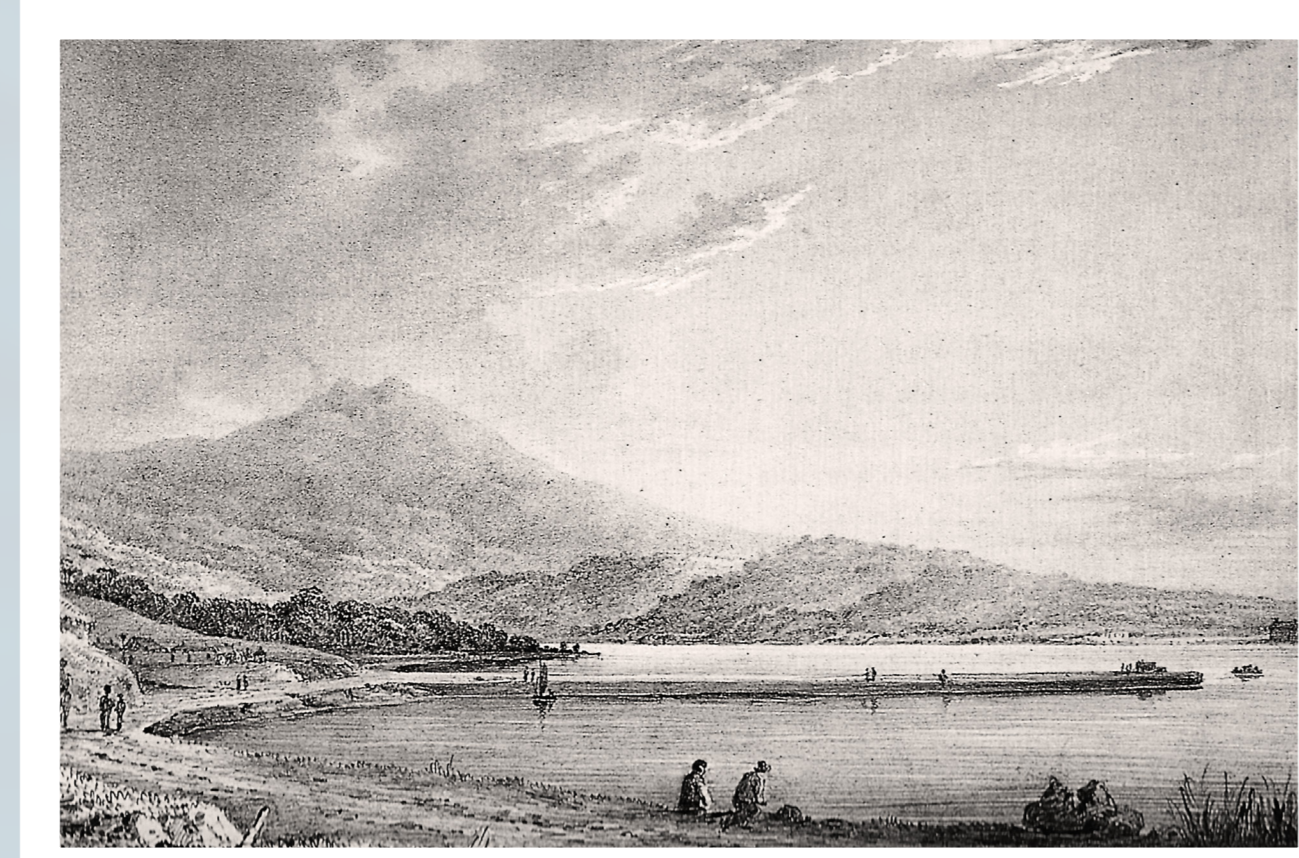
View of Causeway in 1840s with Mount Dromedary in the LHS background with passengers waiting for the punt – Courtesy Tasmanian Museum and Art Gallery

The completed causeway was 730m long but raised and widened a number of times. A large volume of mud was displaced by the mass of rock filling, creating mud banks on either side of the causeway.

Convict-built punts were moved from Port Arthur to the site. Cables were used to haul the punt across the gap, offering a safe crossing, still allowing vessels to travel through the gap.

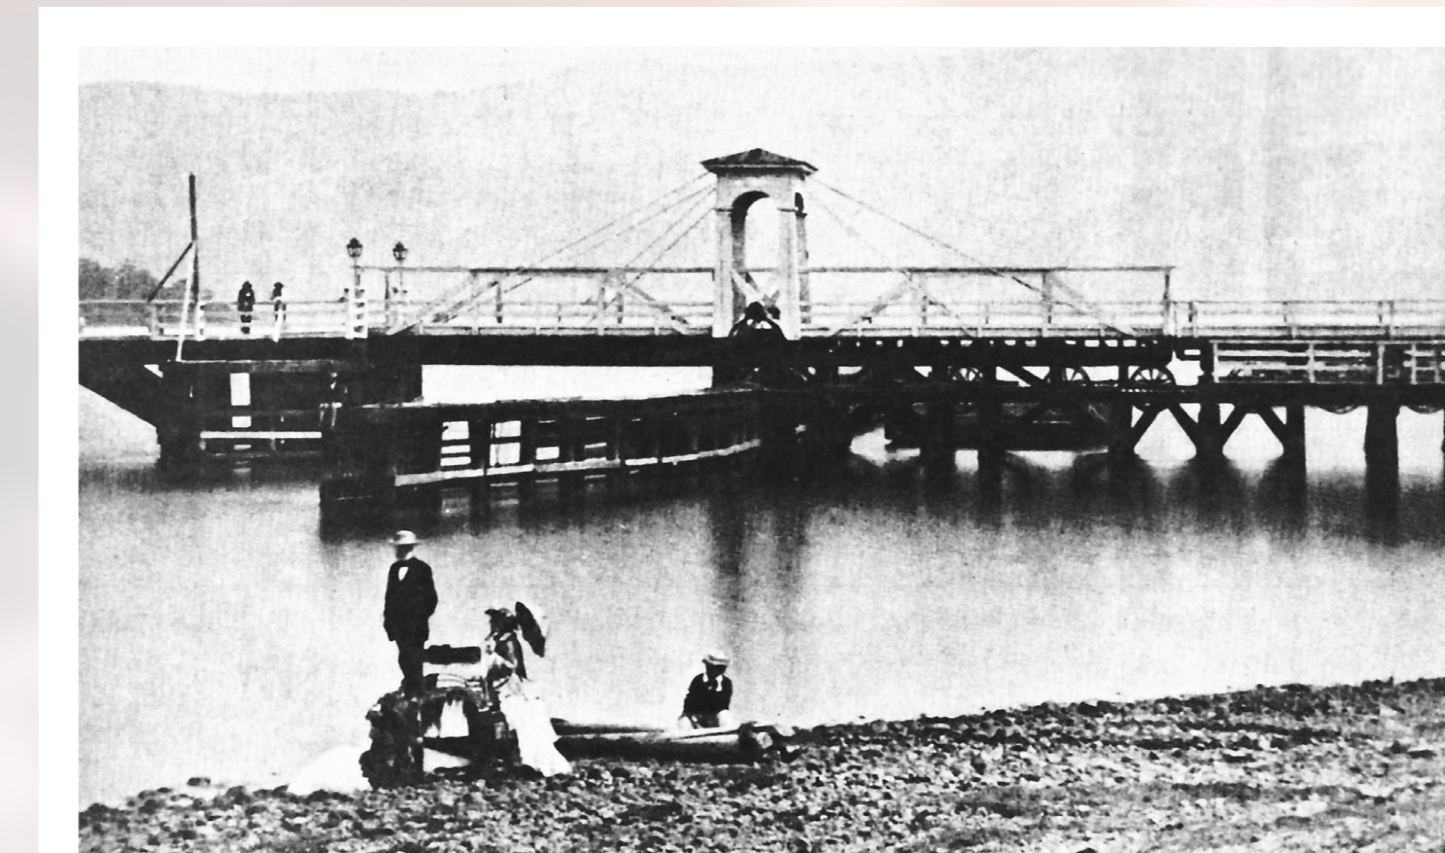
Bridge No.1 view downstream on the northern banks showing tower and timber tow path for vessels. The iron wheels are visible on the right side of the tower. – Courtesy Tasmanian Archives and Heritage Office [TAHO]

Bridge No.1 was built by Thomson and Blackburn in 1849. Timber was sourced from Mount Dromedary for piles and bridge spans. Many of the 363 piles needed were 18m to 27m, presenting a formidable problem of pile driving. A timber rolling truss spanned the navigation channel. The truss was 23m long, supported on iron wheels and iron rails, and operated by hand winches. Additional support for the rolling span was a central tower with chains at each end.

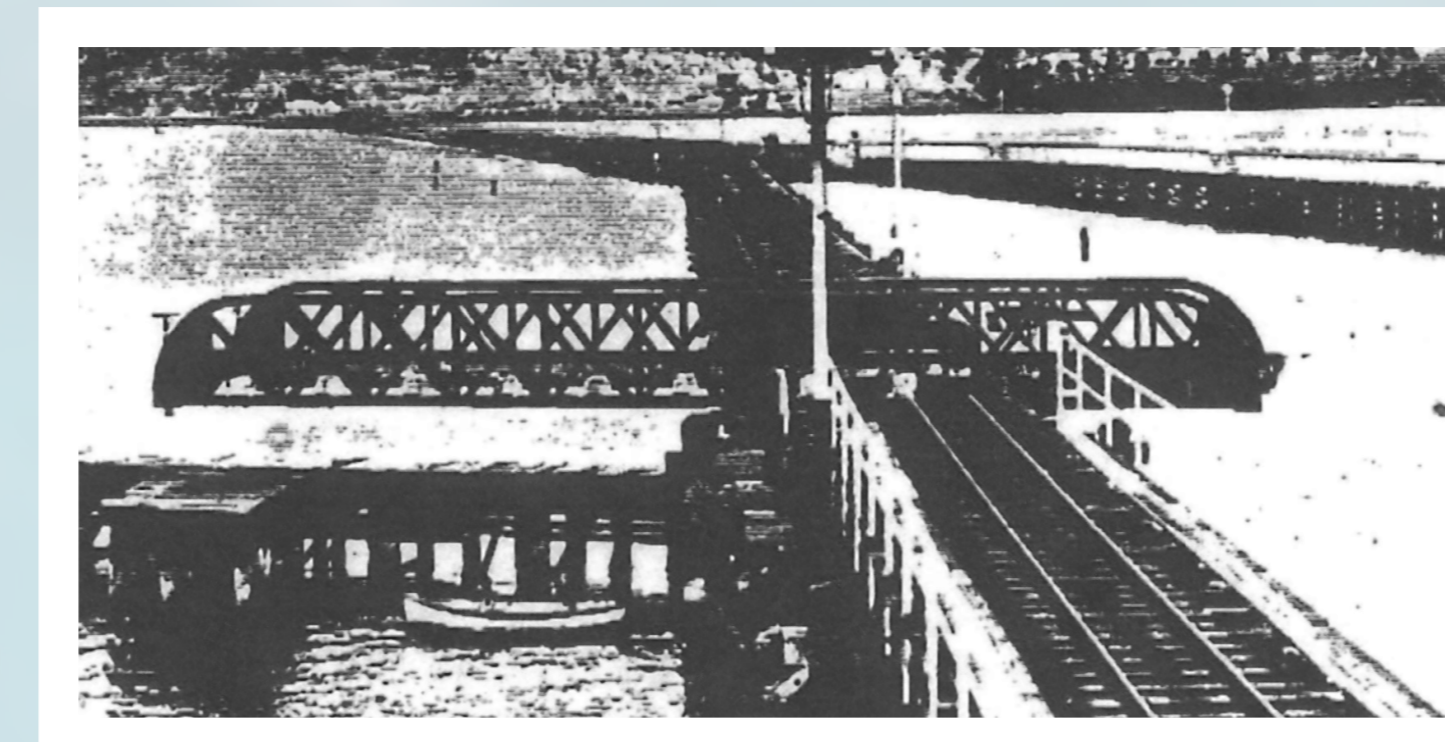
Bridge No.2 rail bridge swing span open for vessels – Courtesy TAHO

Bridge No.2 With the introduction of rail in the 1870s, a connection between Hobart and the north was important. The causeway was widened on the downstream side to accommodate the rail track and bridge. The works were completed in 1874 with the rail deviating east from the causeway, ending some 15m downstream from the road bridge. The movable part was a swing span of steel lattice girder also operated by hand winches. A tow path was also constructed to guide vessels between the two bridges.

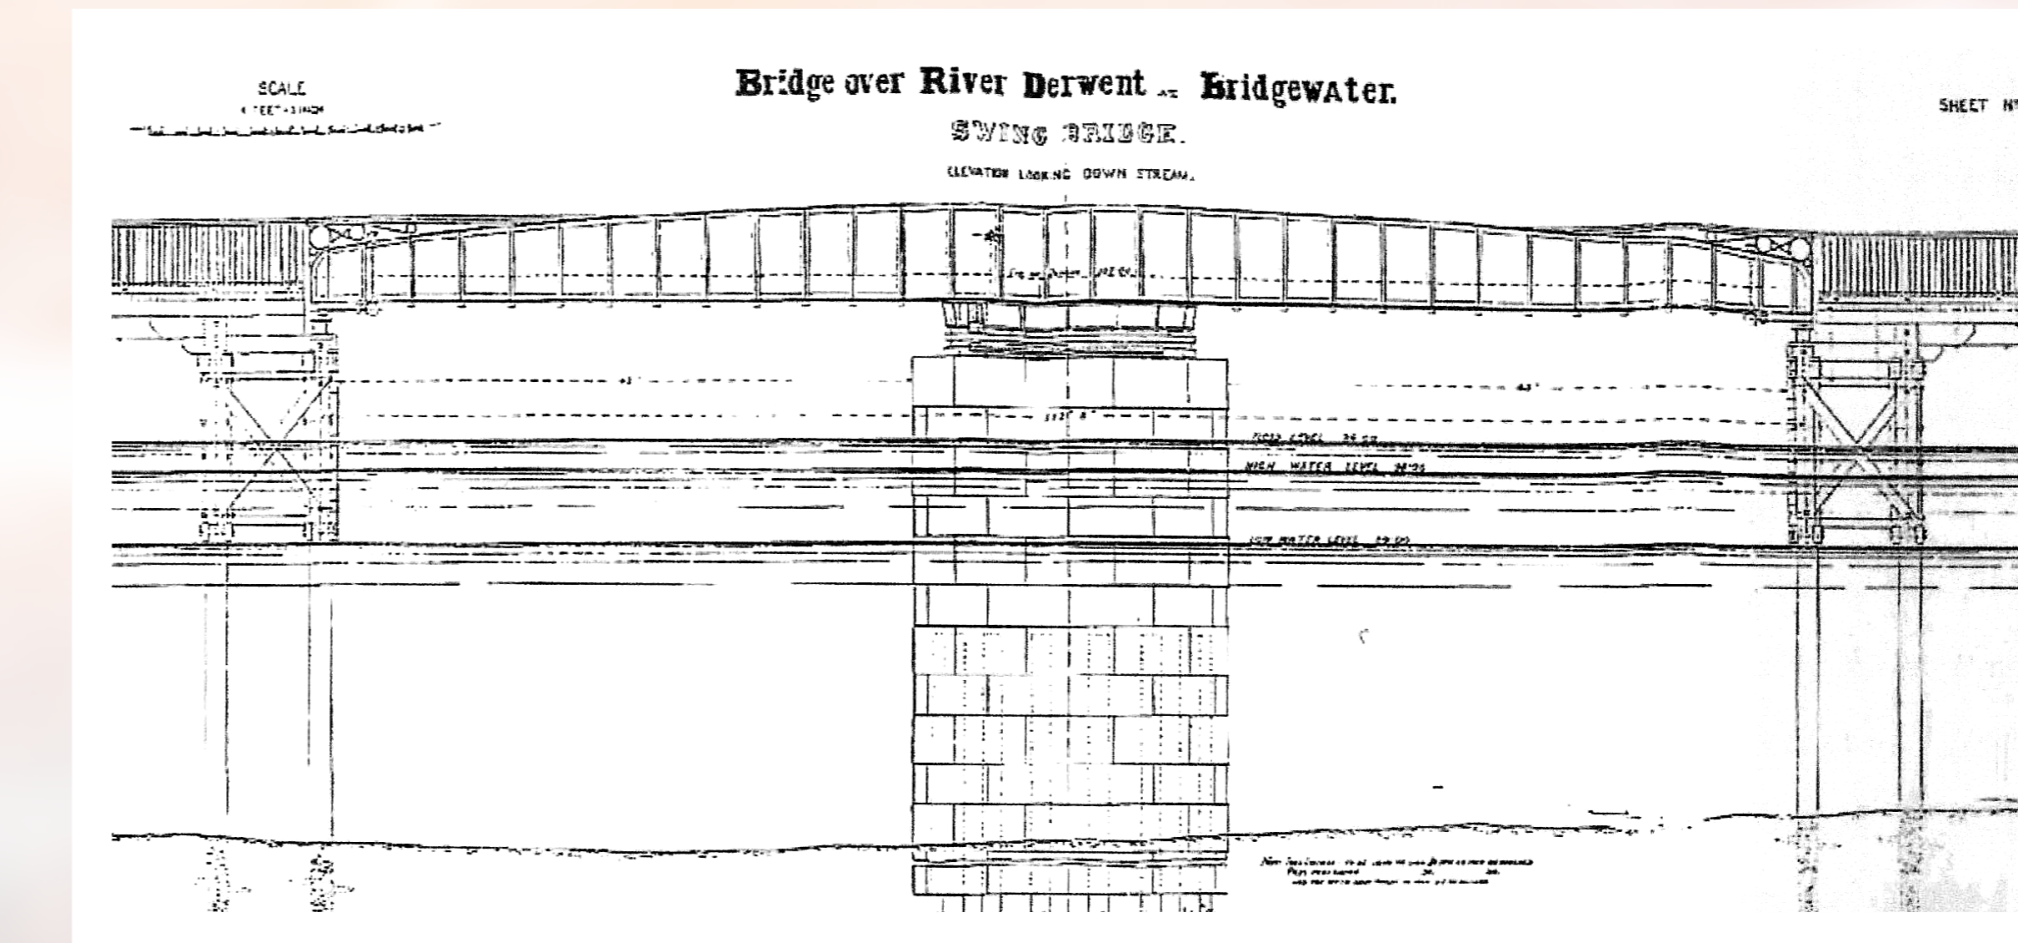
Bridge No.3 road and rail bridge swing span – Courtesy TAHO

Bridge No.3 In 1892 a contractor from South Australia, Wishart and Son, was awarded the tender for a swing span road bridge that extended straight out from the causeway. Originally needed for road traffic, the bridge was also designed for conversion to rail.

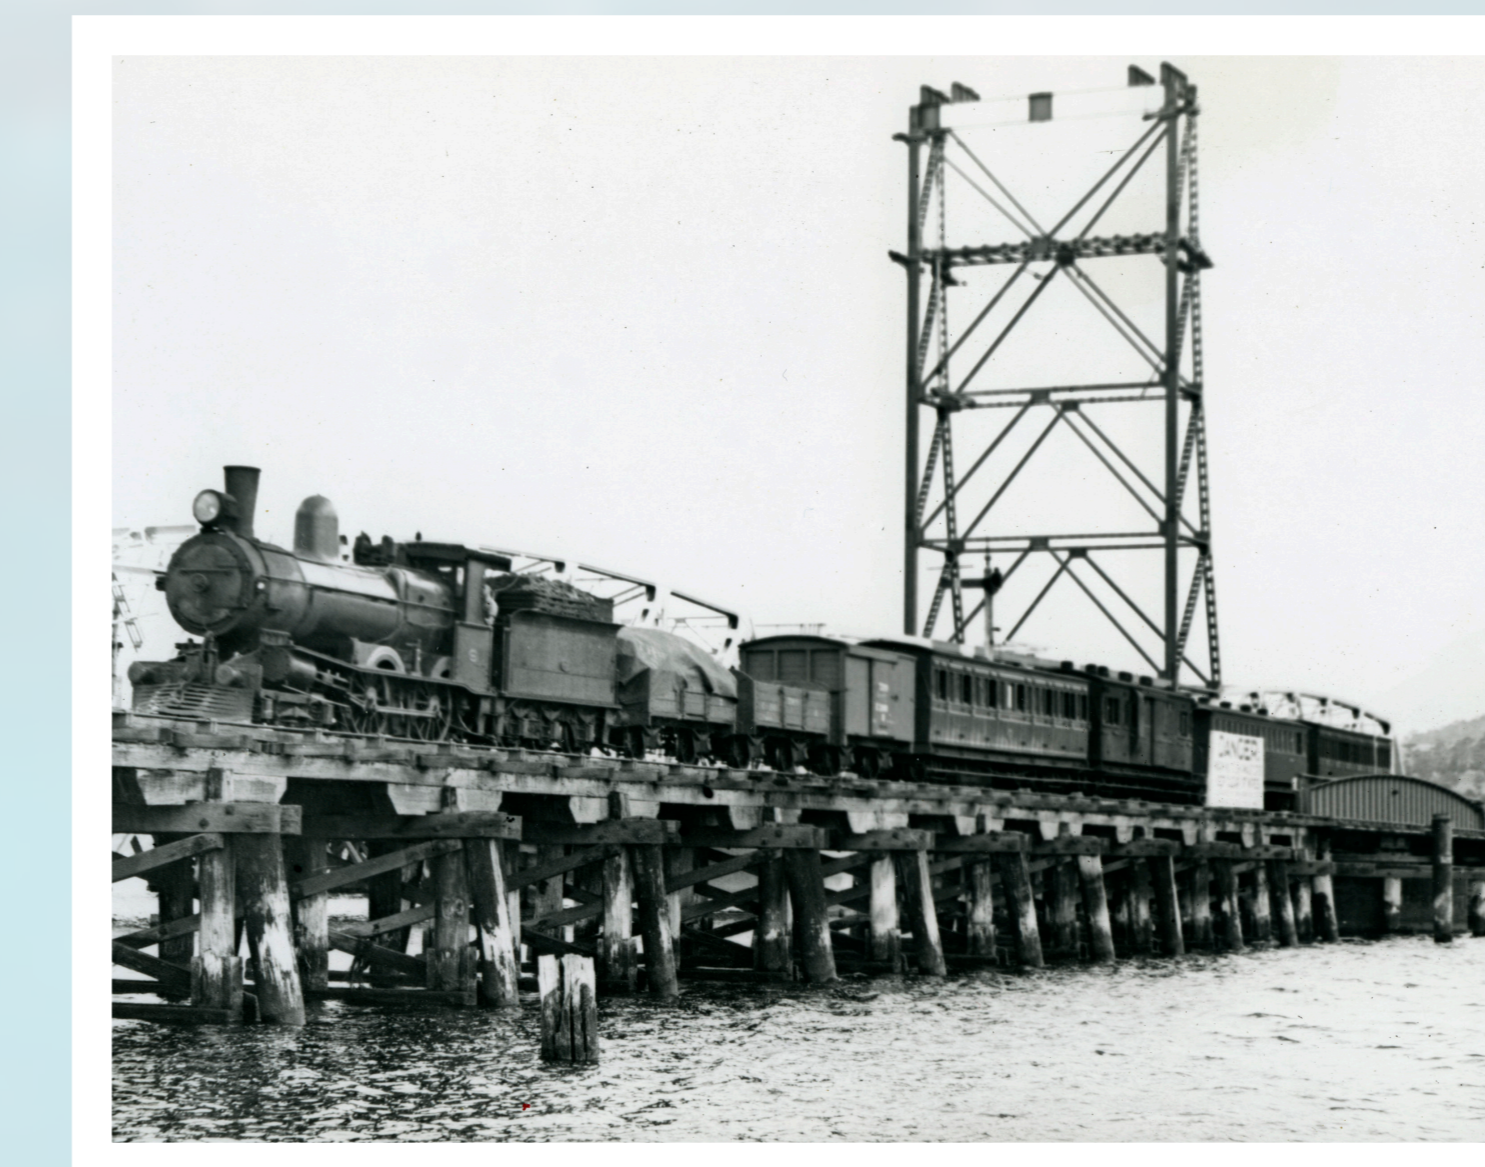
Train crossing the 1893 bridge with the tower of Bridge No.4 under construction c1940 – Courtesy Tasmanian Government Railways

Bridge No.4 The current Bridgewater Bridge is an all-welded structure including the towers, lift span truss and the two truss approach spans. There are two northern steel girder approach spans with nine on the southern approach. The designer and Chief Engineer, Allan Knight (later Sir Allan) was determined to consider weld fatigue in the design of the bridge and engaged David Isaacs, a pioneer in the field.

Isaacs found that the stress in fillet welds may not be uniform causing an increased risk of fatigue cracking. His decision was to join members with butt welds that were uniformly stressed.

Work commenced in 1938 but was halted during the Second World War. In 1942, the bridge was opened to limited road traffic. The full deck was completed in 1944, the lift span in August 1946 and the rail crossing in October 1946. River navigation through the misaligned spans of the three bridges during construction was difficult, so the two redundant bridges were demolished.

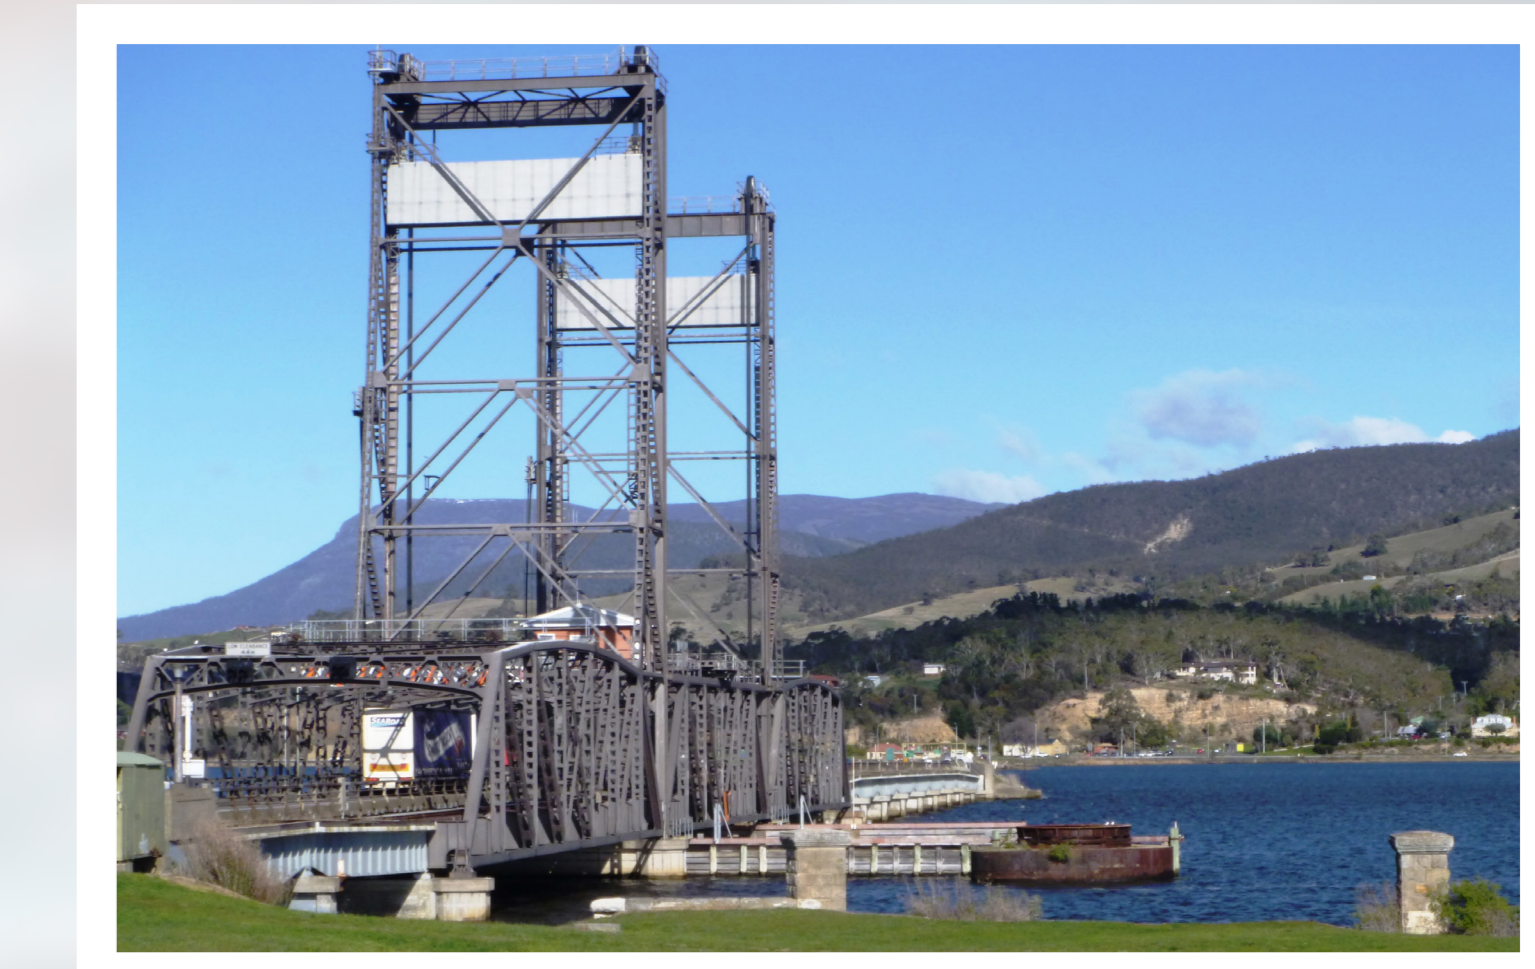
Bridge no.4 the current bridge looking south shows heritage items of the early abutments and steel caisson of the 1893 bridge. On the southern bank is the quarry where stone was dug with pick and shovel and barrowed to the water's edge – Courtesy Ian D Cooper

This bridge has been operational for over 75 years carrying 20,000 vehicles per day with 10 per cent commercial vehicles. The bridge has been maintained and strengthened over the years but there has been no sign of weld fatigue.
